OFFICE OF EXPERIMENT STATIONS—BULLETIN 179.

SMALL RESERVOIRS

WYOMING, MONTANA, AND SOUTH DAKOTA.

F. C. HERRMANN,

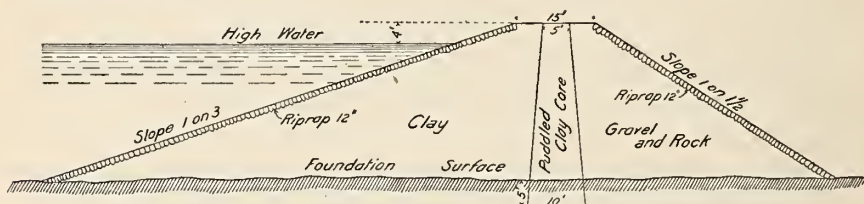
FIG. 1.—Section of dam of Dome Lake Reservoir, showing arrangement of material.

rapped with large boulders, of which there is an abundant supply near at hand. It is purposed to arrange the material in the dam in the manner shown in figure 1, placing the selected impervious material between the core wall and the upstream face to secure water-tightness, and the gravel and rocks below the core wall to insure drainage. In this manner it is hoped to prevent saturation of the body of the dam and seepage beneath it. On account of the rather unfavorable character of the foundation, an earthen dam with a broad base, distributing its weight over a large area, is undoubtedly the best type to be chosen, and though the present tendency of engineers is to avoid clay puddle cores, it would be difficult in this case to provide otherwise against loss beneath the dam. The danger of settlement would certainly preclude the use of a concrete core wall. The riprapping of boulders on the water slope of the dam is to be placed directly on the earth, and as there are seldom very high winds in this vicinity, owing to its protection by surrounding hills, it would appear that this will suffice to resist the action of the waves, though it doubtless would be a wise provision to insert a layer of gravel or broken stone between

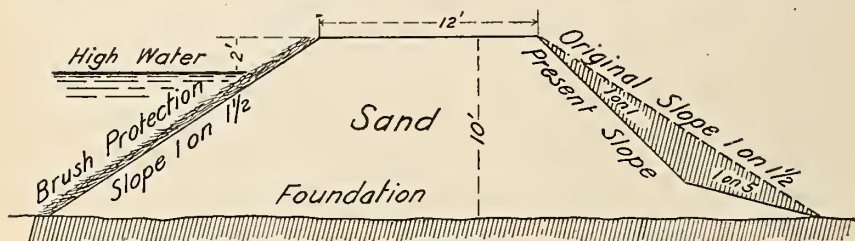
FIG. 2.—Change in outer slope of Colorado Dam, due to saturation.

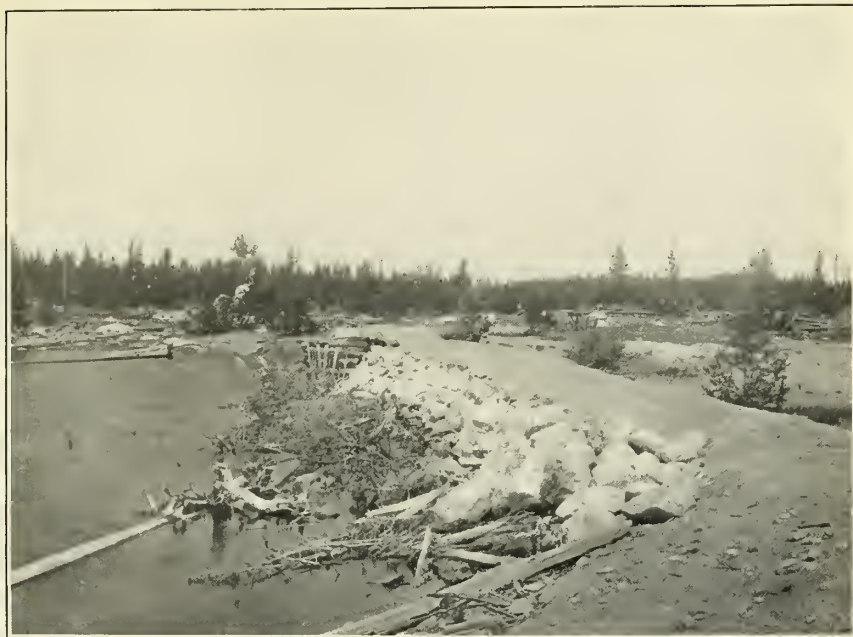
FIG. 1.—ONE OF THE COLORADO RESERVOIRS, SHOWING HOMEMADE GATE FENDER.

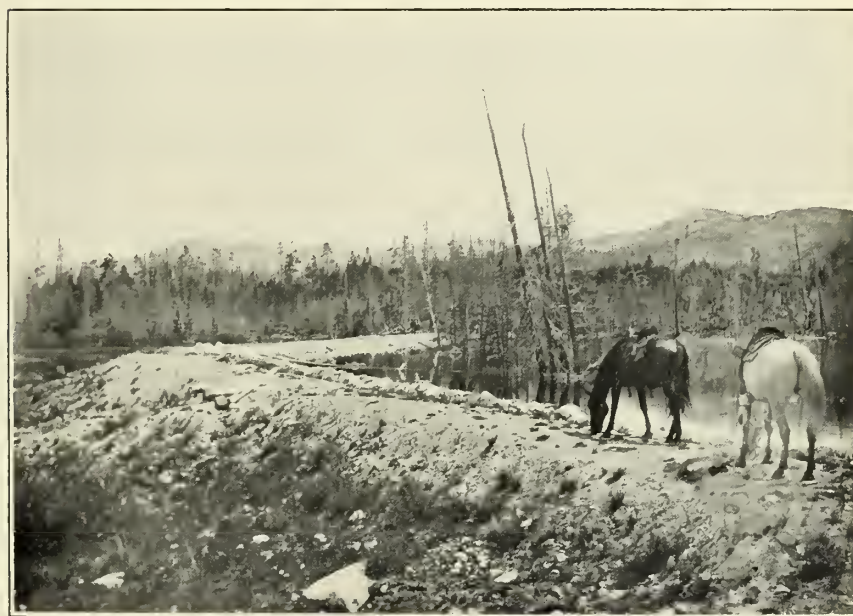
FIG. 2.—LAST CHANCE RESERVOIR DAM, SHOWING RIPRAPPING FOR WAVE PROTECTION.

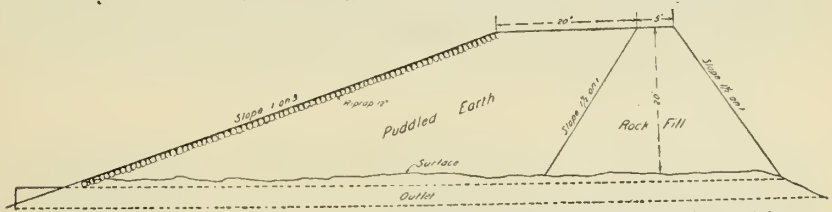
FIG. 3.—Section of Clouds Peak Reservoir, showing proposed disposition of material.

The type of dam first chosen was a combination of earth and loose rock, there being necessary for a dam 20 feet high about 15,000 cubic yards of earth and 6,000 cubic yards of loose rock. The disposition of these materials was to be as shown in figure 3, which does very well

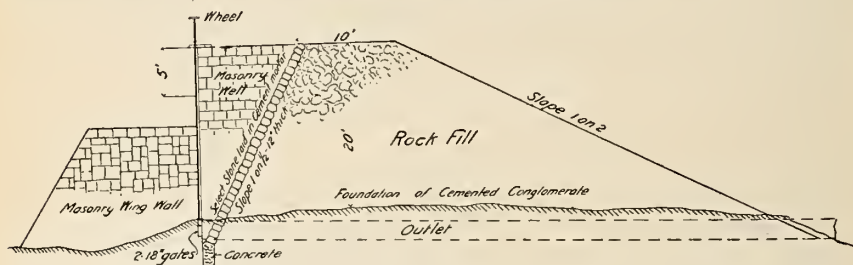
FIG. 4.—Section of Clouds Peak Reservoir, showing disposition of material.

can be repaired easily when the water in the reservoir is low. The stones in the wall will occupy positions normal to the slope, which in itself will tend to withstand the tendency toward cracking. The slope of 1 on 2 on the outer slope is ample. It is planned to provide ample wasteway around the end of the dam, which will in no way interfere with the toe of same, the dam standing in no danger of being overtopped. The outlet passes through the cemented rim rock and, save for the walls and gate well, is not connected with the body of the dam.

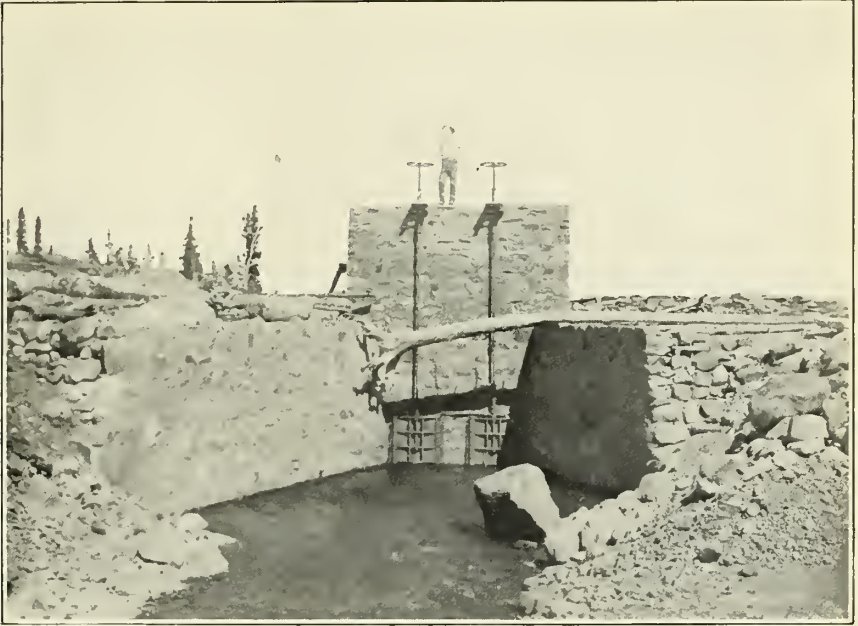
FIG. 1.—OUTLET OF CLOUDS PEAK RESERVOIR.

tection of the entrance to the gates, and a concrete well, by means of which the gates are operated. This gate with well and walls is shown in Plate III, figure 1. These gates, weighing several tons each, were taken from the railroad some 50 miles from the reservoir, and, on account of their weight and make, had to be hauled all the way intact, which precluded the use of pack animals. For the first 40 miles, or to the base of the Big Horn Mountains, no serious difficulties were encountered, but for the last 10 miles there was no road. By the use of a great many animals and ingenious methods for braking, these gates were hauled in a wagon over exceedingly steep mountains, through thick timber and brush, and over very rough gorges and canyons, the path taken being even now a difficult one for a man on horseback. The sacks of cement used in the concrete work were transported by pack animals at great expense. On account of the shortness of the working season, and the difficulty for men to work at such a high altitude, progress has not been rapid, though by the fall of 1905 the outlet was complete and the foundation of the dam was partially cleared. It was the intention to install derricks and a cableway as soon as the season of 1906 opened, and to carry on the remaining work with all possible speed.

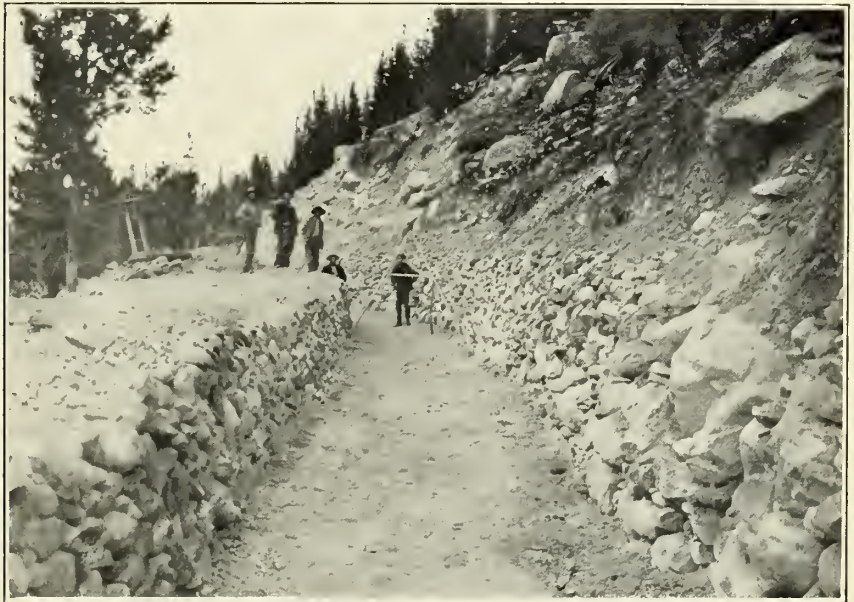
FIG. 2.—SECTION OF OUTLET DITCH OF CLOUDS PEAK RESERVOIR, SHOWING LINING OF DRY STONE WALL.

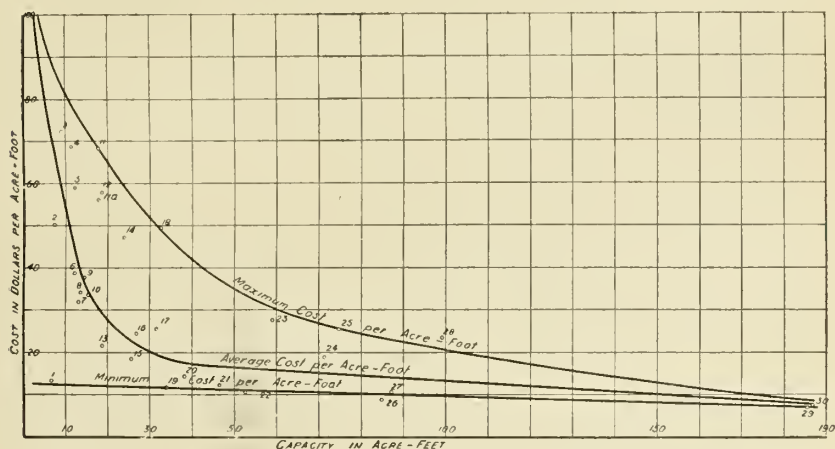
FIG. 5.—Diagram showing cost of reservoirs.

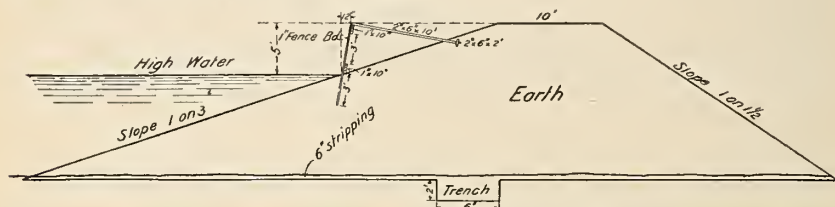
FIG. 6.—Standard cross section of earth dams of Chicago and Northwestern Railway, showing position of intersecting trench.

was the only material available, there being in most cases not a stick or stone for many miles. In constructing the first of these reservoirs no special effort was made to secure a bond between the dam and its foundation, and the sides were given the steepest slope at which the material being used would stand. It was soon demonstrated, however, that a perfect bond between dam and foundation was imperative, and that a much flatter slope on the water side of the dam was necessary to withstand the action of the water. The standard cross section at present has a top width of 10 feet, a water slope of 1 on 3, and an outer slope of 1 on $1\frac{1}{2}$. To insure water-tightness along the joint between the dam and its foundation, the sod is scraped off the foundation for a depth of 6 inches and an intercepting trench dug parallel to the axis of the dam. This trench has been placed in various positions between the toe of the inside slope and the crest of the dam. At present, however, its position is just inside the inner edge of the crest of the dam, as shown in figure 6.

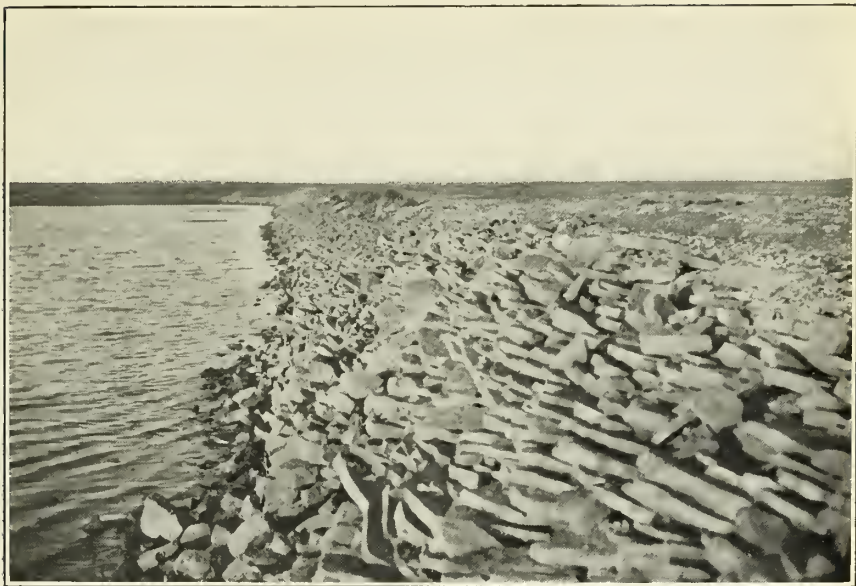
FIG. 1.—TISDALE RESERVOIR, NORTHWEST OF CASPER, WYO., SHOWING ACTION OF WAVES ON PITCHING.

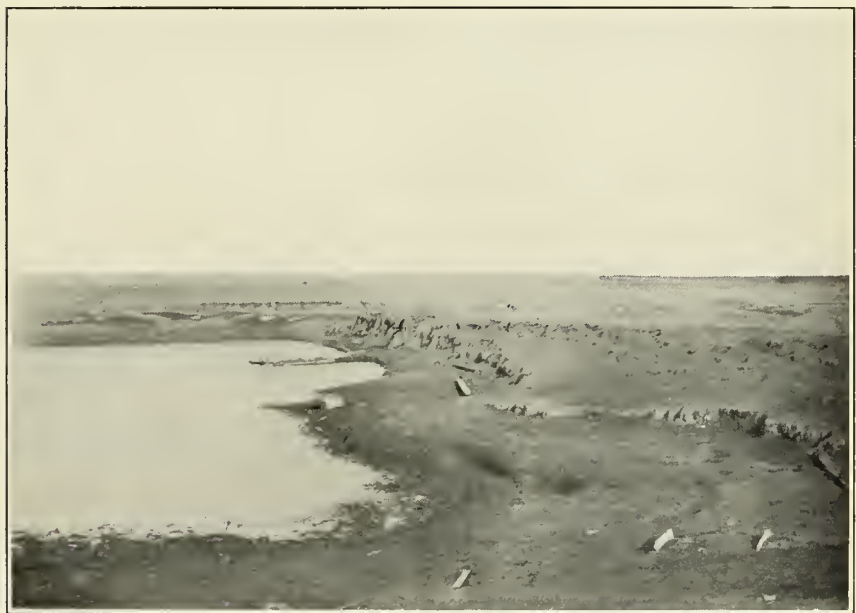
FIG. 2.—RIPRAP ON DAM OF CASPER CREEK RESERVOIR, 12 MILES WEST OF CASPER, WYO.

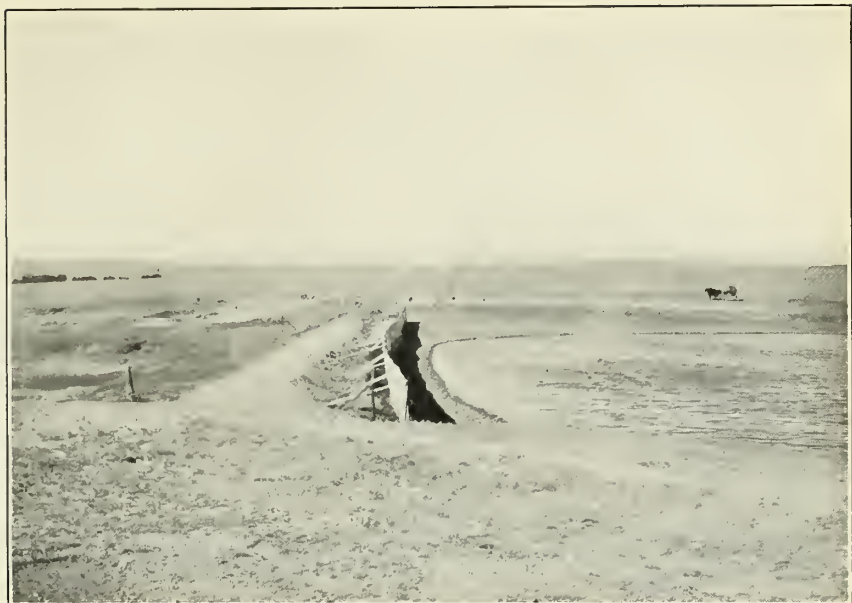
FIG. 1.—WAVE FENCE WITH LONG BRACES.

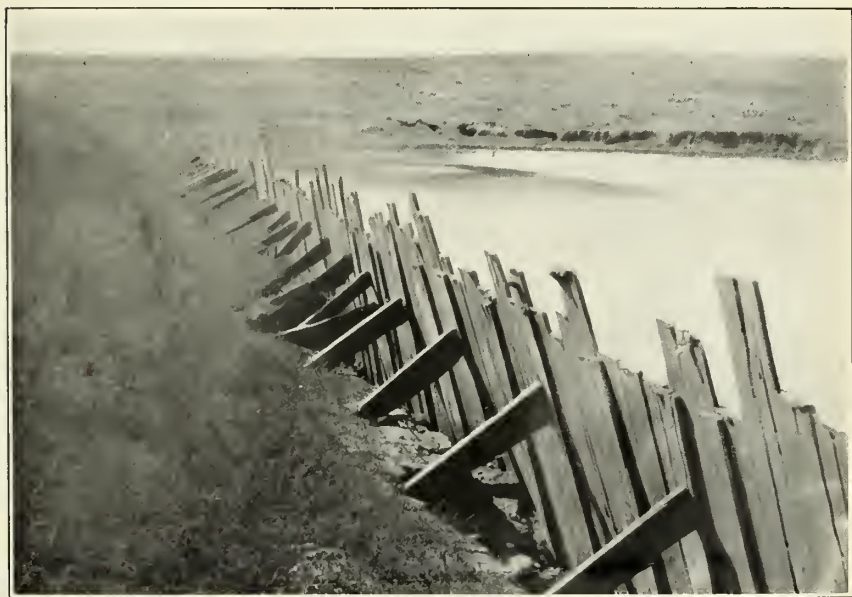
FIG. 2.—WAVE FENCE WITH SHORT BRACES.

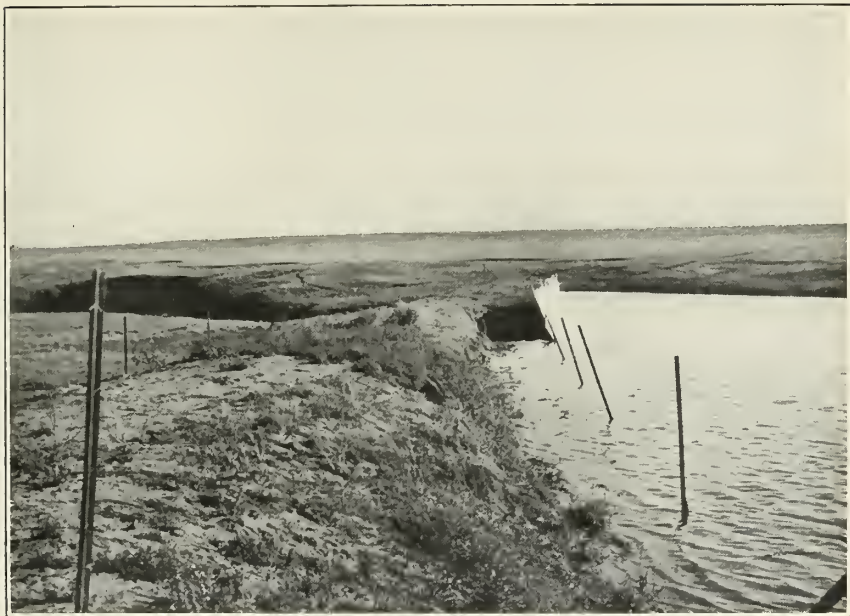
FIG. 1.—NEW BULL CREEK RESERVOIR, SHOWING EROSION WHERE FENCE HAS BEEN STOLEN BY CAMPERS.

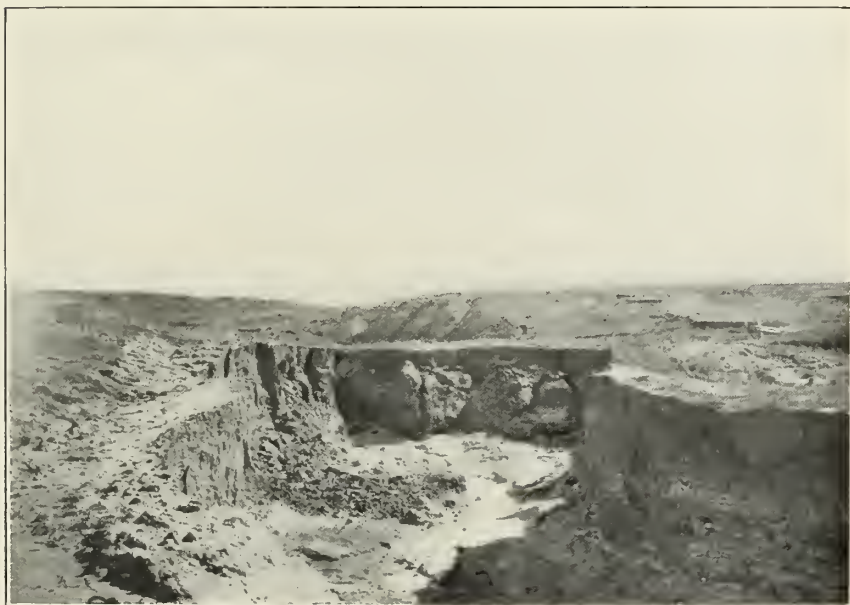
FIG. 2.—EROSION OF WASTEWAY OF CROW RESERVOIR, NORTH OF BELLEFOURCHE, S. DAK.

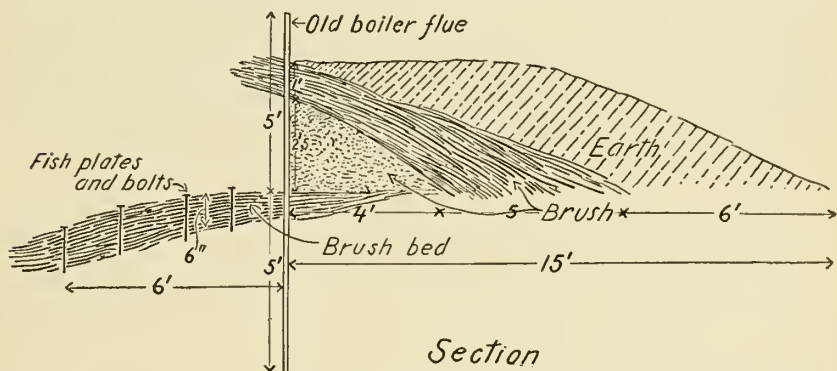
FIG. 7.—Brush drop in wasteway.

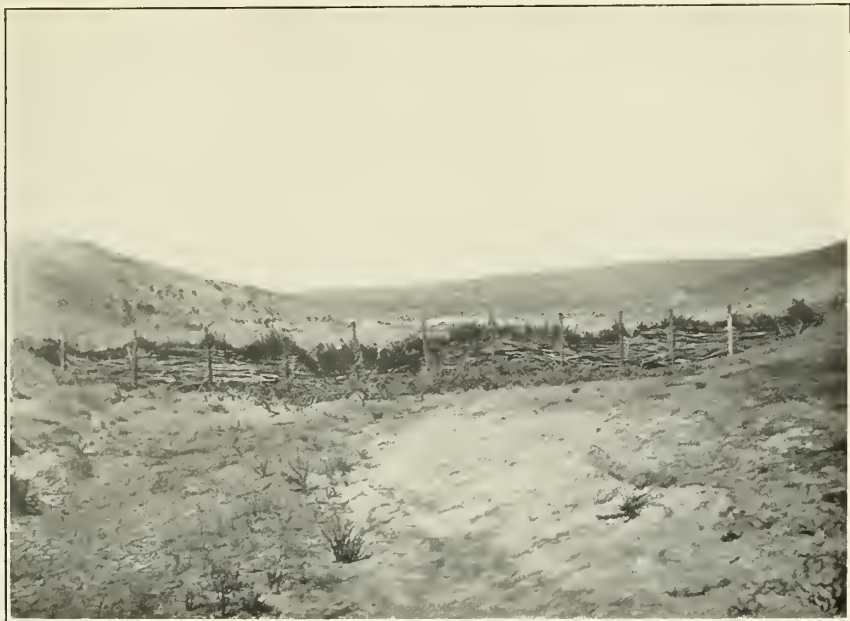
FIG. 1.—BRUSH CHECK IN THE WASTEWAY OF BOX ELDER RESERVOIR.

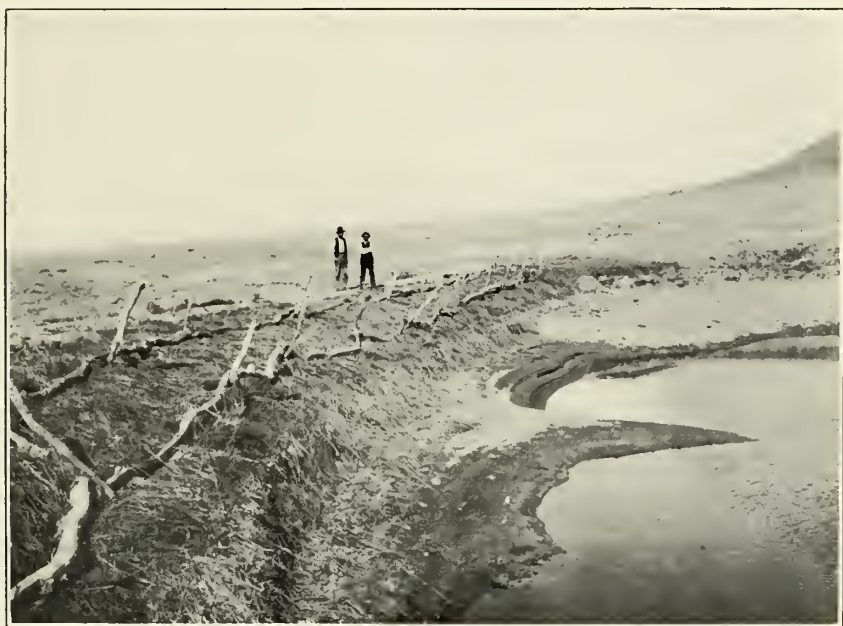
FIG. 2.—BRUSH PROTECTION FROM WAVES ON DAM OF HARRIS RESERVOIR NO. 2, ON TRAIL CREEK, MONTANA.

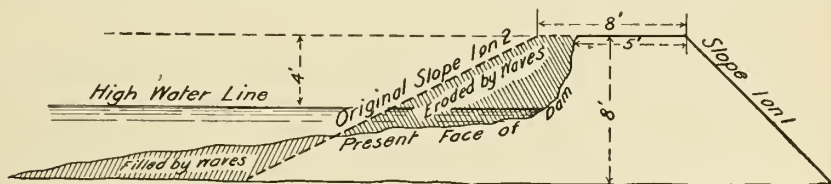
FIG. 8.—Section of dam of Brant Reservoir, showing effect of wave action.

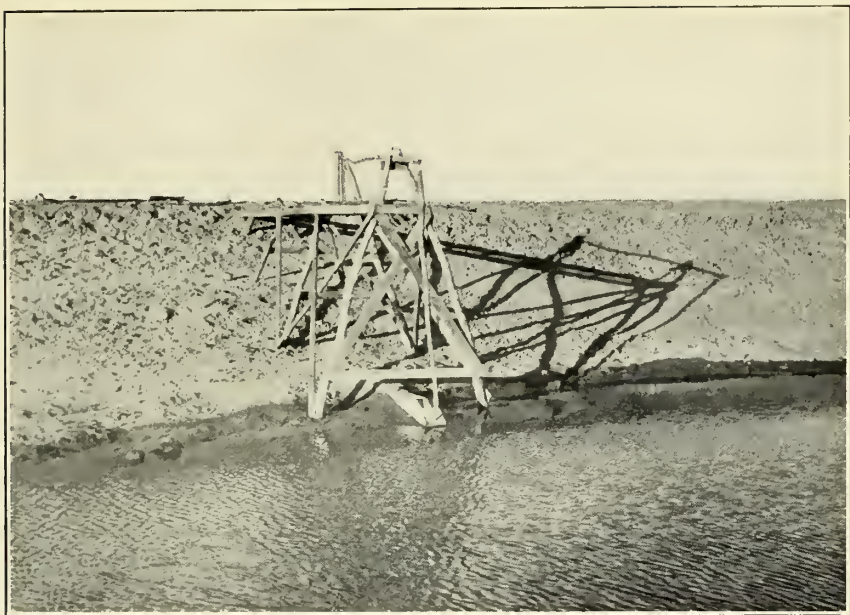
FIG. 1.—OUTLET OF HARRIS RESERVOIR NO. 1.

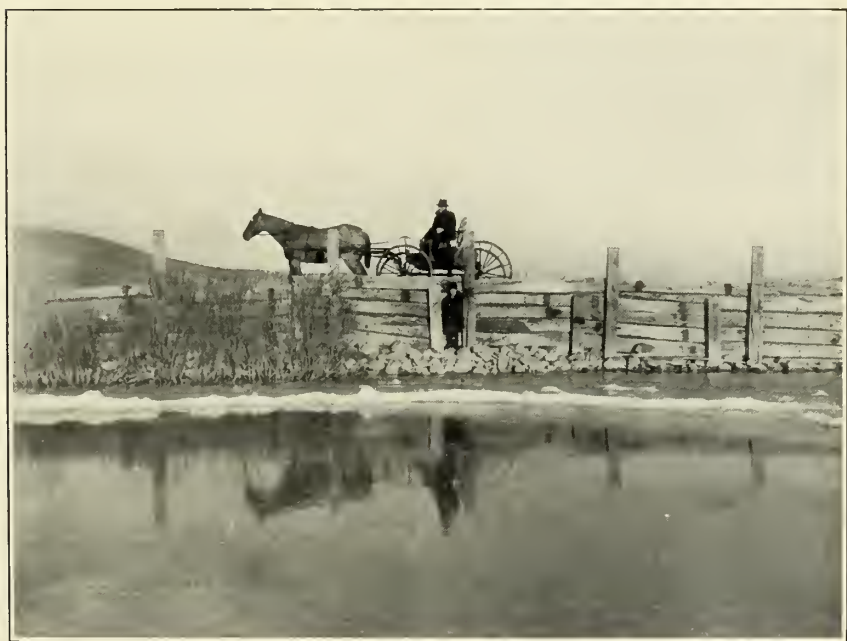
FIG. 2.—GRIFFIN RESERVOIR, 6 MILES WEST OF CHEYENNE, WYO., SHOWING REVETMENT.

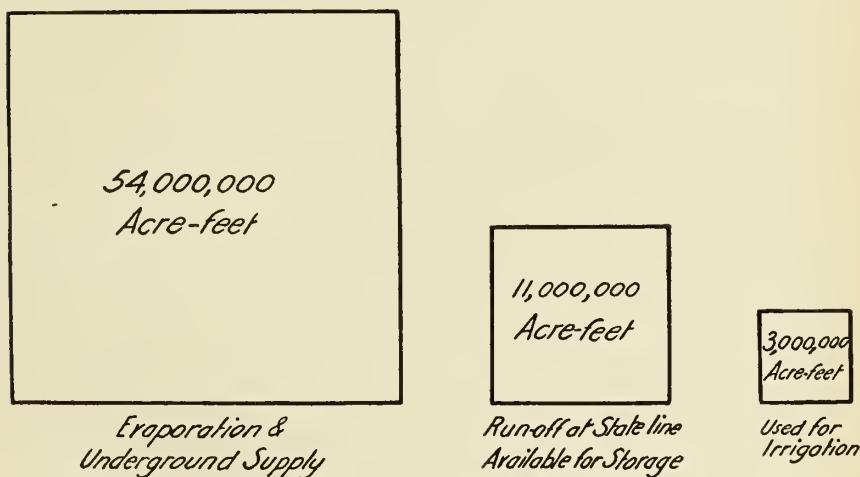
FIG. 10.—Disposition of precipitation in Wyoming.

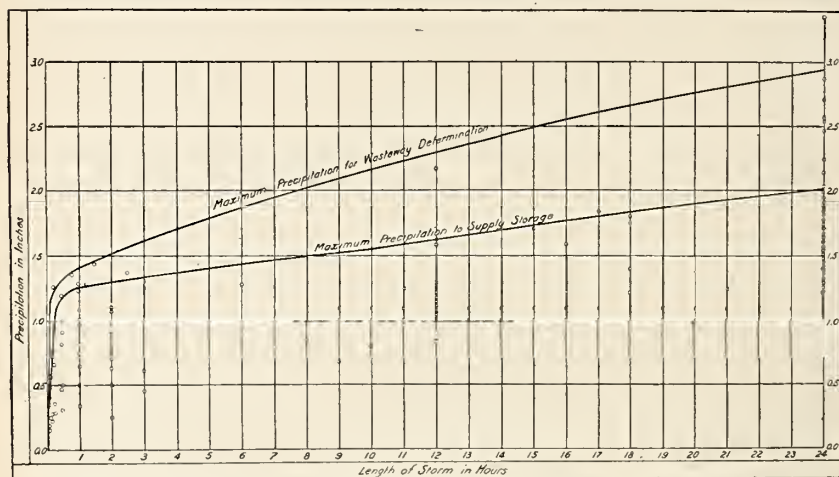
FIG. 11.—Diagram showing maximum precipitation for storms of different lengths.

From these data the diagram shown in figure 11 has been constructed. Two lines are shown, the lower representing the maximum precipitation for storms up to twenty-four hours' duration to be considered available for storage purposes at 100 per cent run-off, and the upper line the maximum precipitation, under same conditions, to be used in estimating the capacity of wasteway. While the increase from two hours to twenty-four hours is reasonably uniform, that for storms less than two hours is not at all so.

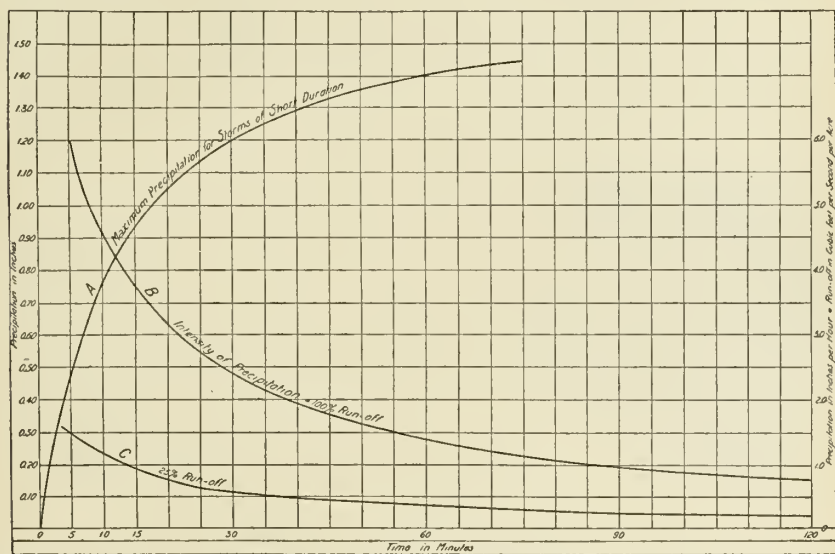
FIG. 1'.—Diagram showing intensities of storms of different lengths and run-off in cubic feet per second per acre.

duration, which is also 100 per cent of the run-off for these storms in cubic feet per second per acre. As much of the precipitation is lost in evaporation, seepage, etc., we never get 100 per cent. The percentage that does run off varies for storms shorter than two hours according to character of slope of catchment area, degree of saturation, and length of storm. With the catchment area well saturated it varies from about 18 per cent for two-hour storms to about 30 per cent for five-minute storms, though this variation is not uniform. A fair average for storms of the character under discussion would be 25 per cent. This is represented by line *C*, figure 12. On page 90 are tabulated the length of storms, maximum precipitation, intensity, and run-off.

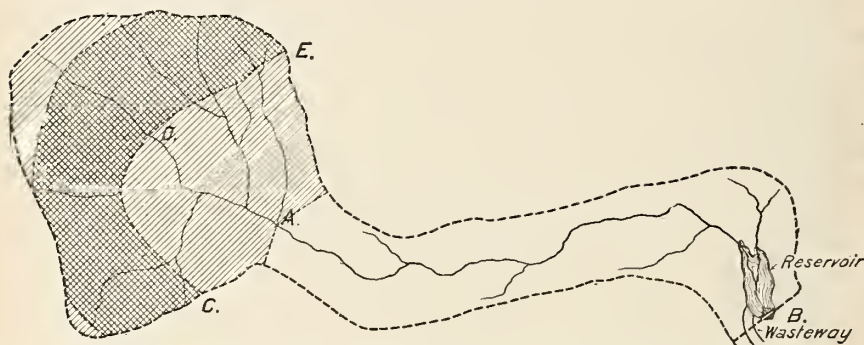
FIG. 13.—Map of a reservoir site and its catchment area in South Dakota.

To illustrate the use of these diagrams, a concrete case will be taken, as shown in figure 13. Here we have a problem presented in South Dakota. The dam and wasteway are located at *B*, from which point the catchment area extends to the left inclosed within the dotted line. The distance from *B* to the most remote point in the watershed is 3 miles, and that from *A* to the most remote point of the watershed above it is 1 mile.

The cross-hatched area lying above the line *C D E* is the maximum area delivering run-off from a storm of fifteen minutes' duration. In other words, if we have a fifteen-minute storm over the upper portion of the catchment area, run-off water starting at the upper edge of this area and traveling at a speed of 2 feet per second will reach the line *C D E* by the end of the storm, so that the waters in the different streams within this area will reach *A* simultaneously and be carried in a body to the wasteway. That that is the maximum area operative during a fifteen-minute storm is seen by inspection. The entire catchment area is 1,040 acres, the catchment area above *A* is 640 acres, and that of the cross-hatched area above the line *C D E* is 320 acres. Assuming a speed of 2 feet per second, it will take run-off water starting from the most remote part of the watershed one hundred and thirty-two minutes to reach *B*, which means that for the entire catchment area to be operative there must be a storm whose duration is one hundred and thirty-
